NFR Winterization Guidelines

2022 – 2023

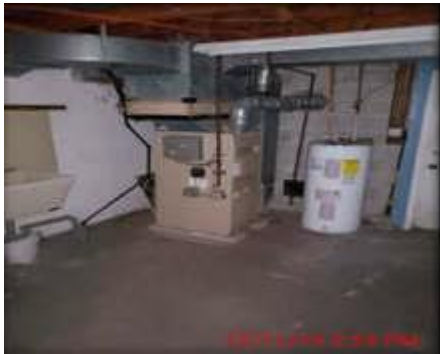
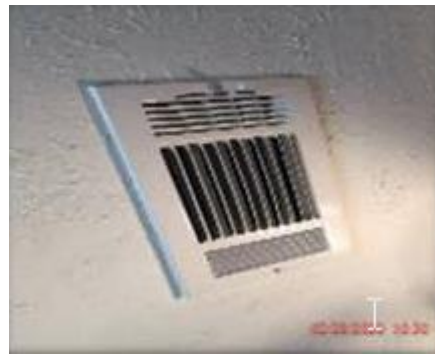
Dry System

- No water involved in heating.
- Systems are forced hot air. They will have furnaces, vents, and/or registers.
- All faucets and valves must be opened in the process of winterization and closed after draining is completed. Photos must support this being done.

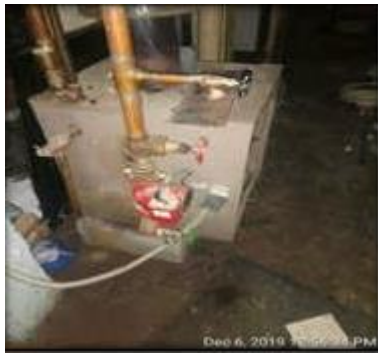
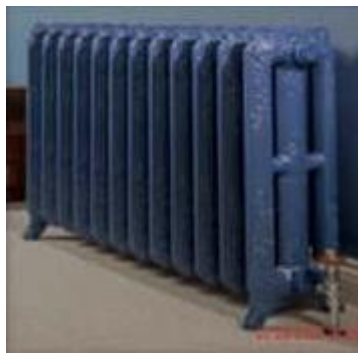
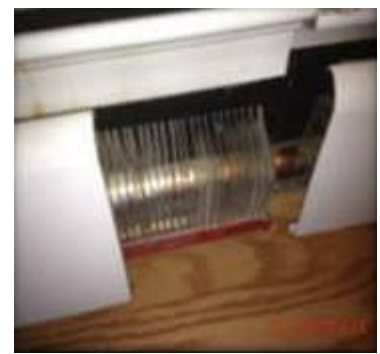
Steam / Wet System

- Has the added complexity of a boiler.
- A steam boiler heats water to create steam through the radiators to heat the property.
- All radiator vents are to be opened in the process; bleeder pins are not be removed. Photos to support this being done.

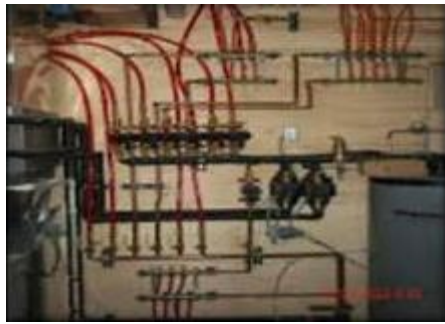
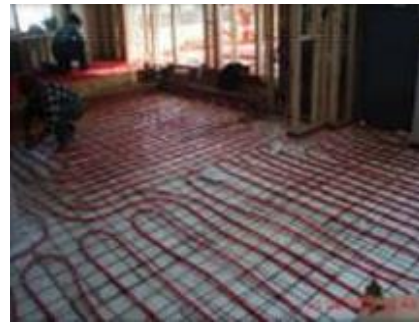
Radiant System

- The heat is spread through the house via water lines in the flooring.
- Consists of an intricate system of PEX lines, valves, and copper called the manifold.
- Radiant piping must be drained and blown dry by compressed air. Photos must support this being done.

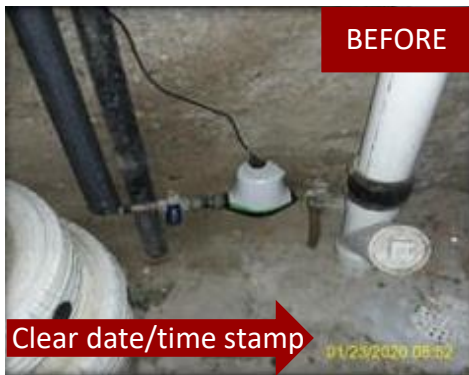
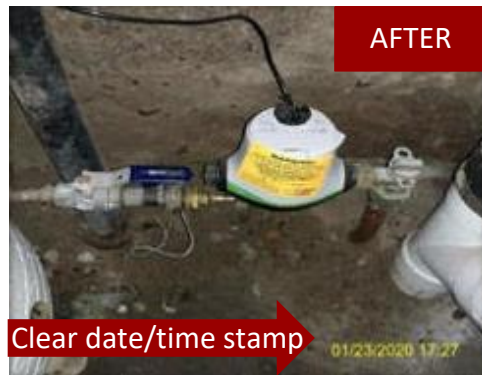
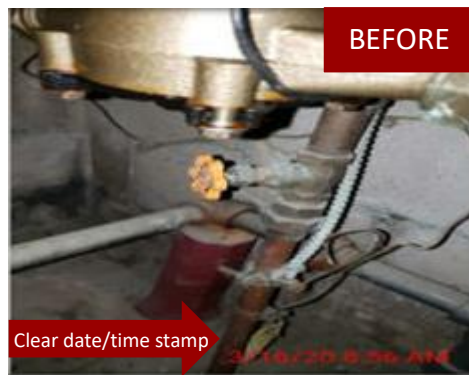
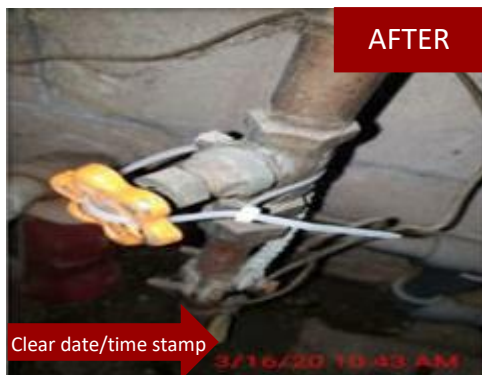
Water Turn Off

Provide photos of appliances / well pump / curb stop to justify water has been shut off.

If you cannot turn off the water at the curb, please turn the water off at each fixture/appliance with photos to justify. On the property condition report, provide authority name and contact information. With this information, NFR can make the necessary arrangements.

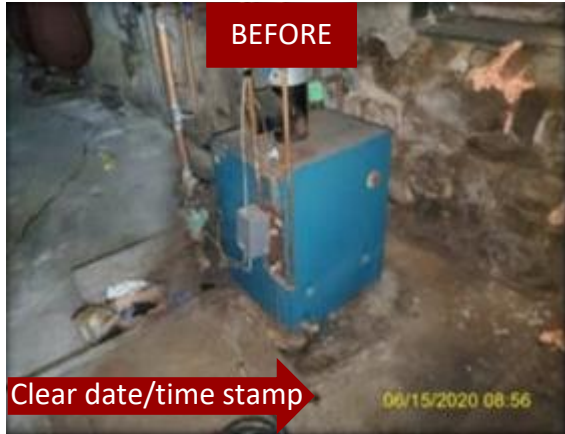
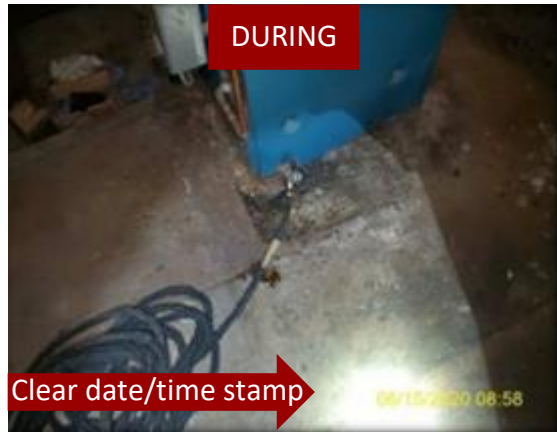
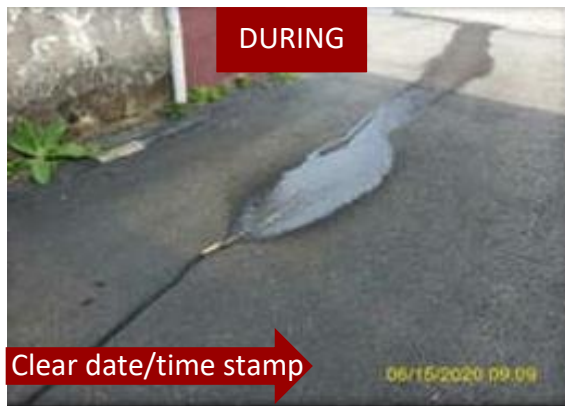
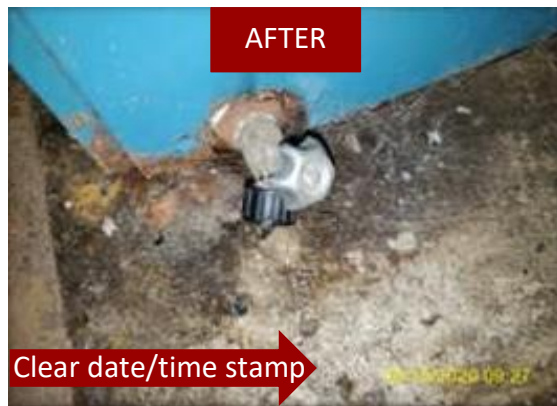
Water Draining (continued)

When draining the hot water heater and/or boiler...

- Provide photos of the hose hooked up to the tank and the other end draining water out to either a floor drain, sink, sump pump, or outside.
- If the hot water heater or boiler is empty:
 - Provide photos to justify that an attempt was made to drain.
 - Make a note on your property condition report.

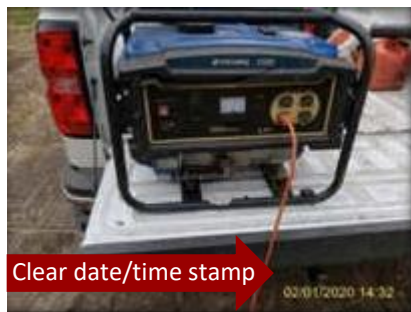
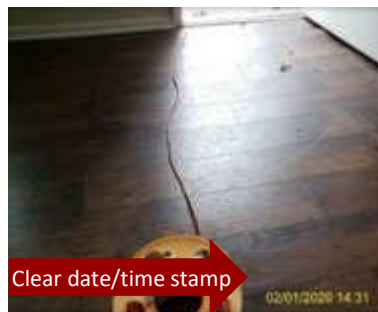
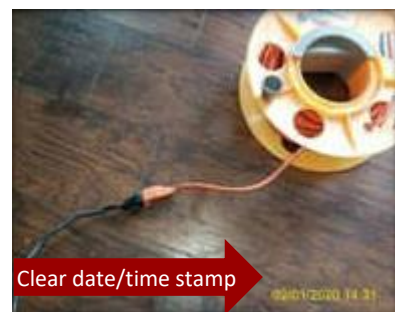
Drain and blow all plumbing loops (domestic and heating lines) to remove any residual water. The air compressor hose is connected to either a faucet, an open water line, or an outdoor spigot.

- Compressor plugged in and the air hose connected to the plumbing.
- Photos of performing a pressure test even if there is damaged or missing plumbing.
 - Show a before photo of the gauge at 0
 - Show an after photo holding pressure
 - Before and after photos must be timed 30 minutes apart.

- Pressure test = 35 PSI for 30 minutes.
- Photos must narrate the work completed.

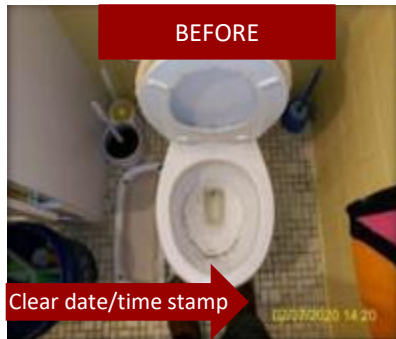
Provide photos of toilet bowl and tank as you found it (with covers open).

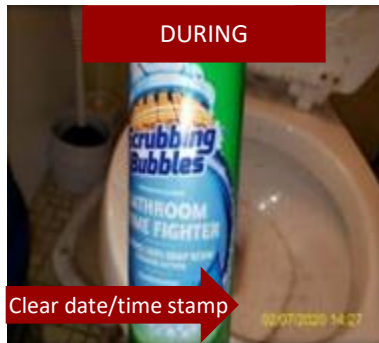
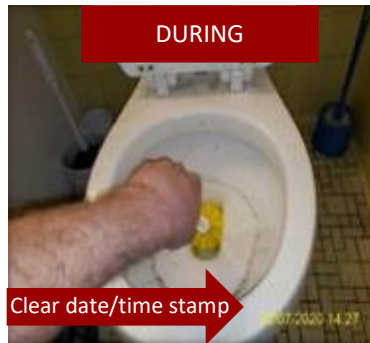
Clean toilet bowls with cleaning agent.

- Provide photos of the cleaning agent.
- Provide photos showing the action of cleaning.

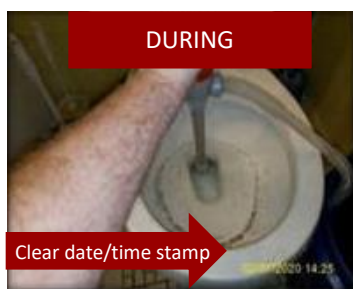
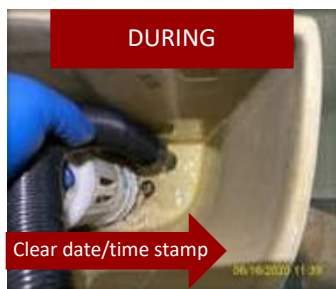
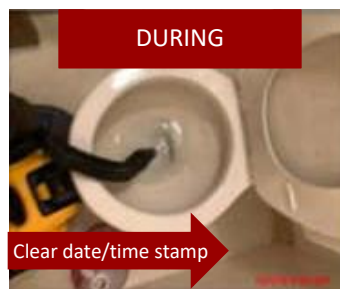
Remove water from toilet bowls and tanks.

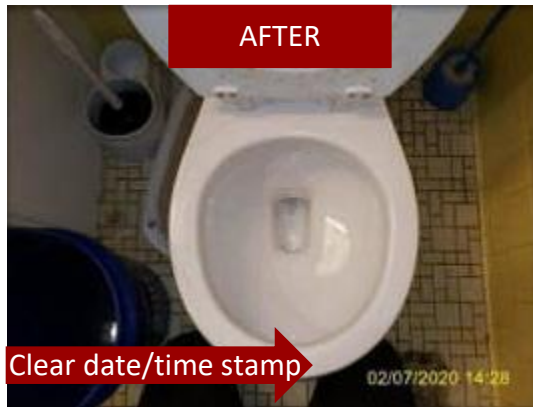
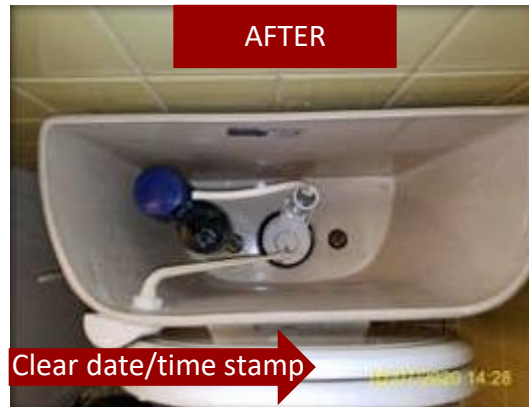
Provide photos of clean toilet bowl and tank void of all water.

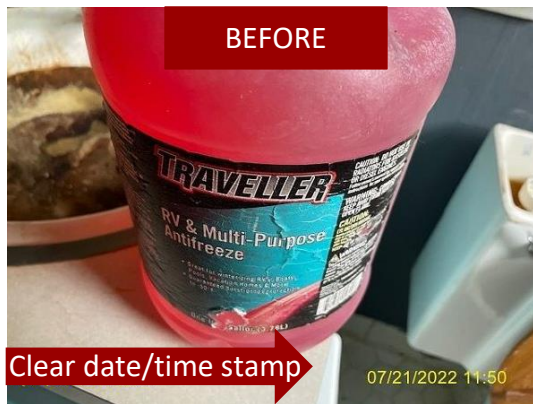
Provide photos of using non-toxic RV antifreeze.

NOTE: Please do not leave empty jugs at the property.

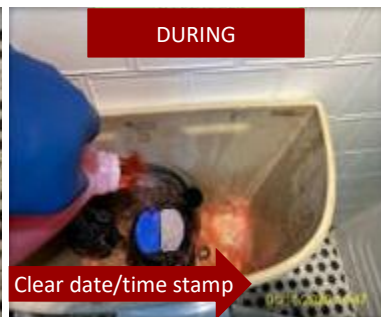
Provide photos of pouring an appropriate level of antifreeze.

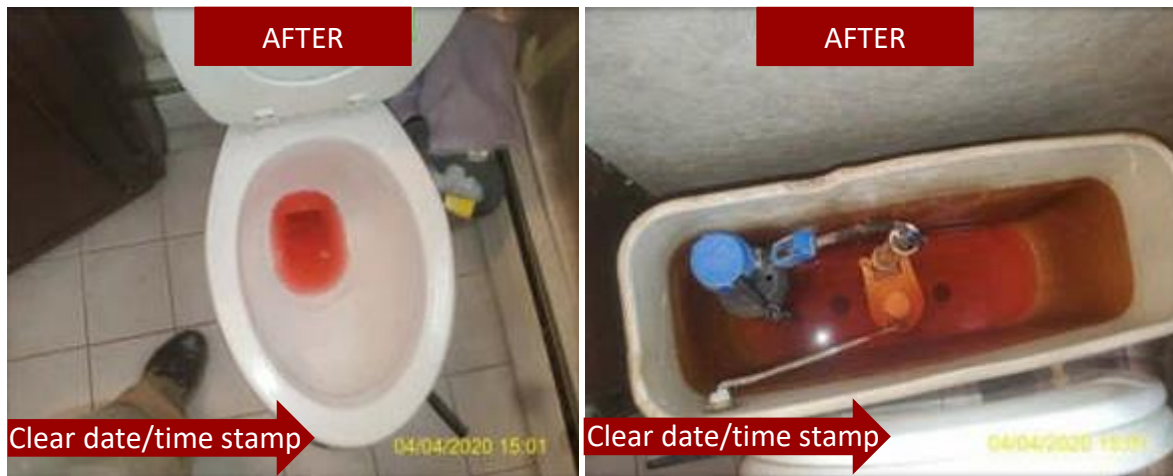
Provide photos of the toilet bowl lid open and a full shot showing standing antifreeze in the toilet bowl and tank.

NOTE: The level of antifreeze must be above the trap. If evaporation is a concern in your area due to climate, please add enough antifreeze to prevent frequent need for refreshes.

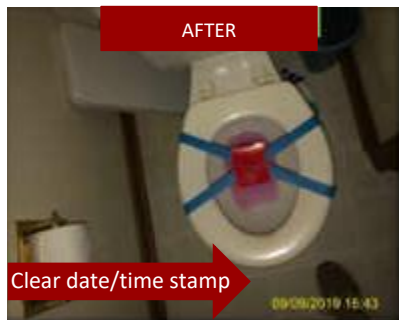
Place winterization sticker on toilet / tank.

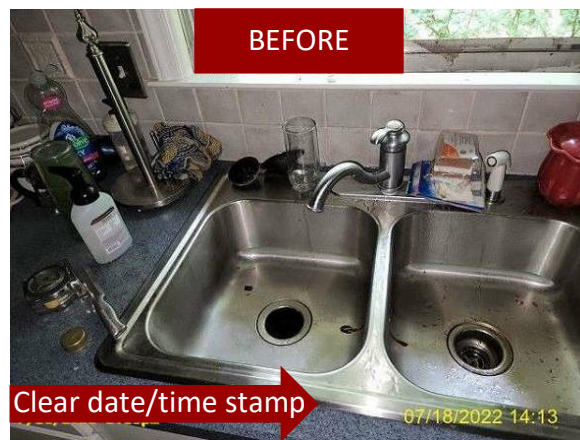
Provide photos of every drain as you found it. (Dishwasher, sinks, tubs, etc.)

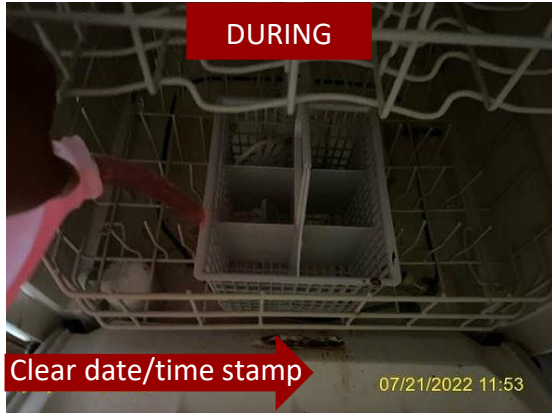
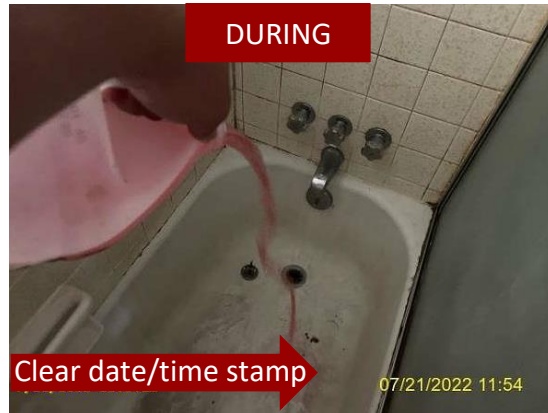
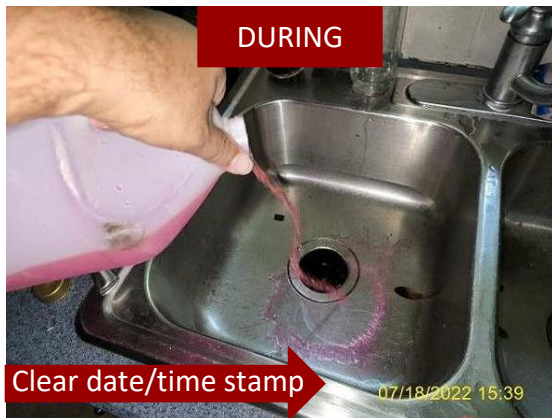
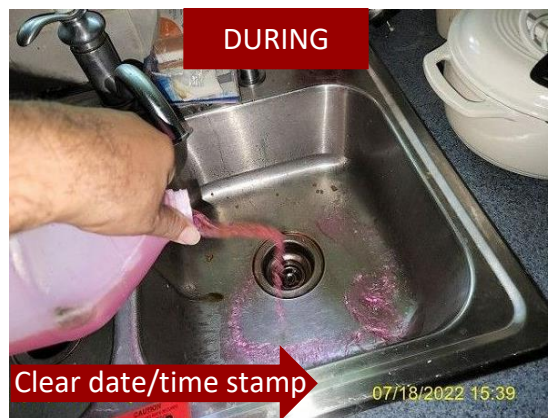
Provide photos of pouring an appropriate amount of antifreeze to every drain. (Dishwasher, sinks, tubs, etc.)

NOTE: For double sinks, pour antifreeze on both sides.

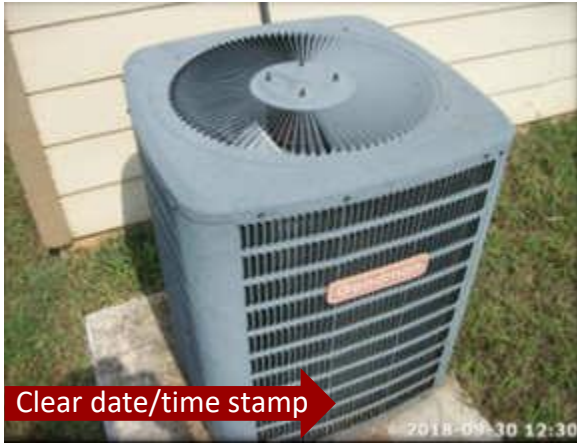
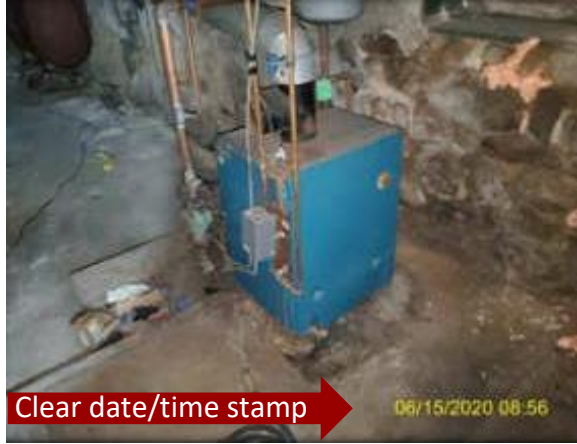
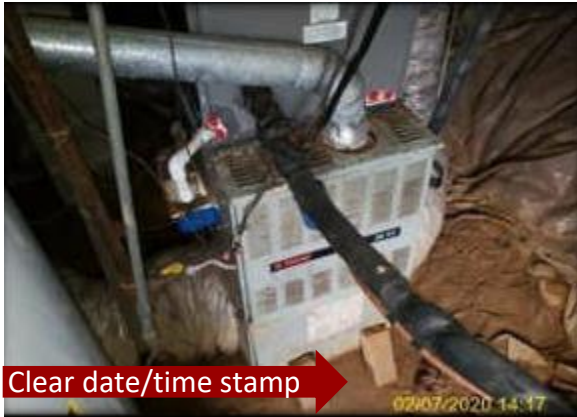
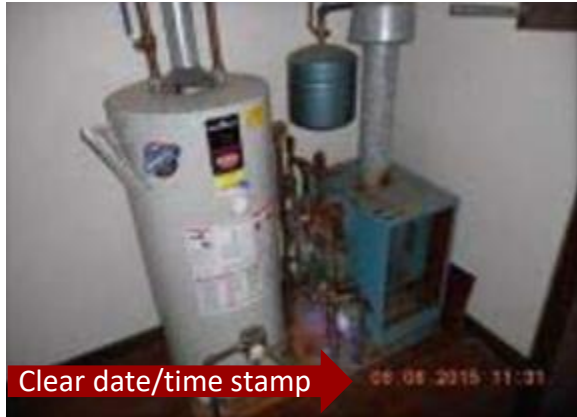
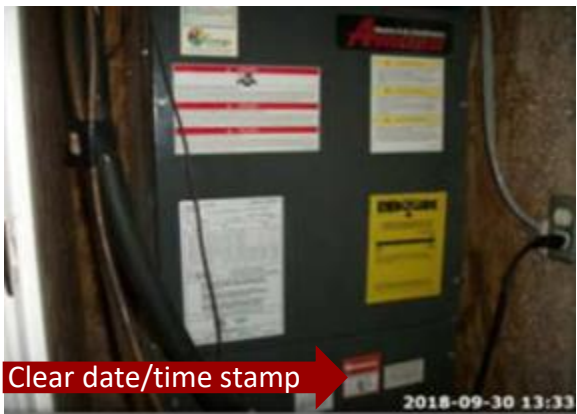
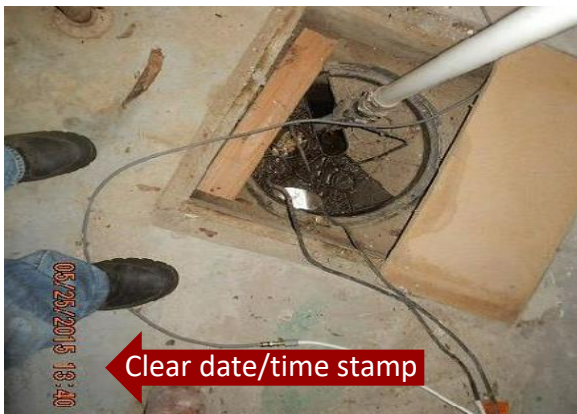
Provide photos showing location and condition of all mechanicals at the property (HVAC, water heaters, boilers, sump pump, etc.)

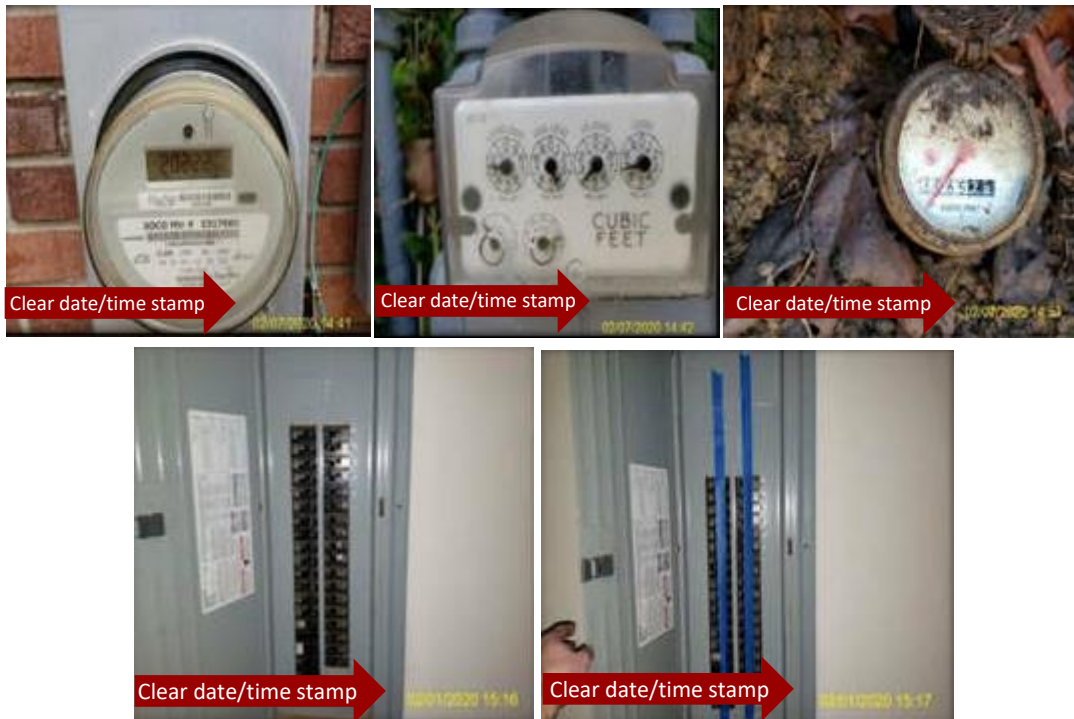
Utilities

- Meter (close up to allow meter reading)
- Breakers in the off position

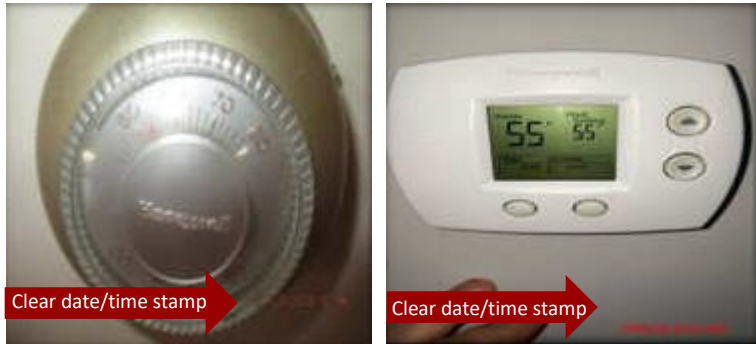
If utilities have been restored, provide photos showing the thermostat is set to 55 degrees, or per municipality regulations.

NOTE: If temperatures warrant, and the heat has not already been restored, please provide utility contact information.

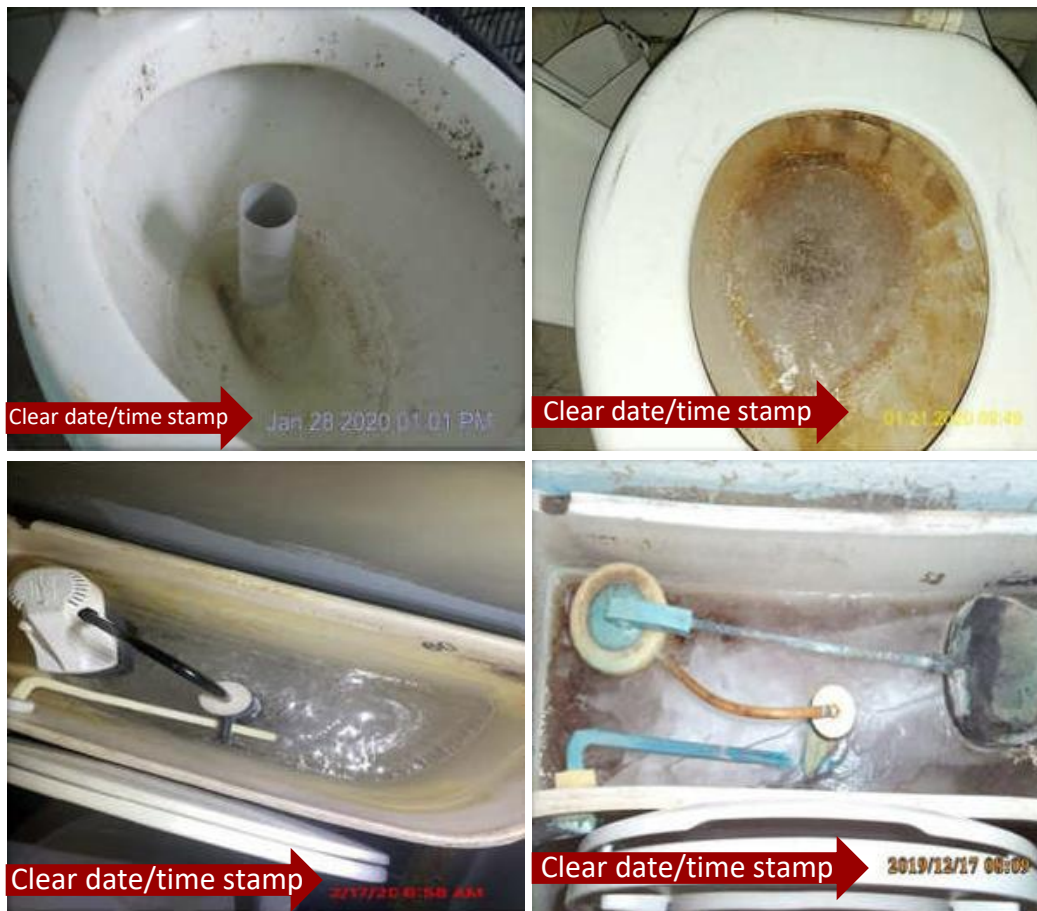
Frozen property:

Provide photos of frozen plumbing, ice buildup, and/or ice slush.

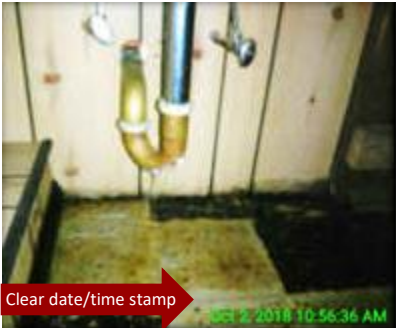
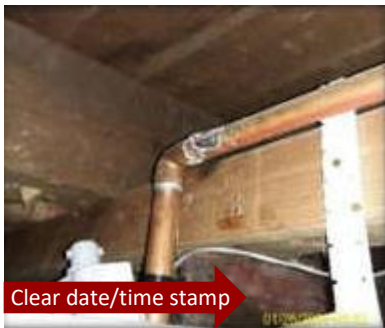
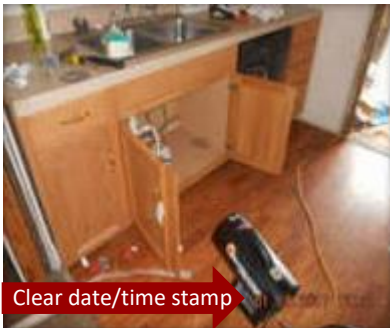
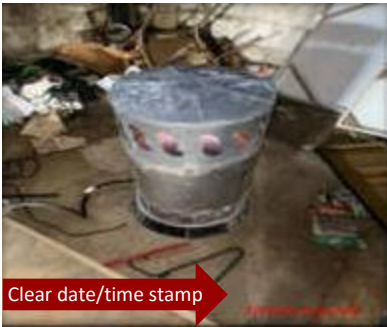
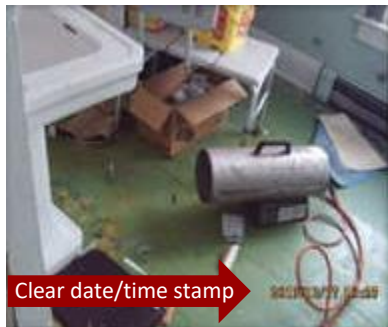
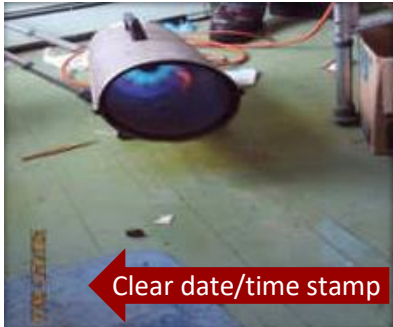
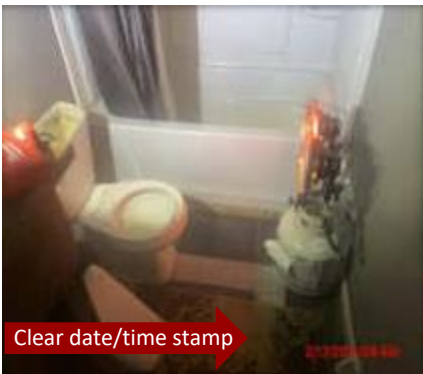
Plumbing damages and examples of thawing process:
